Rigghill Wind Farm
EIA Report
Figure 3.3

Access Track Cross-Section

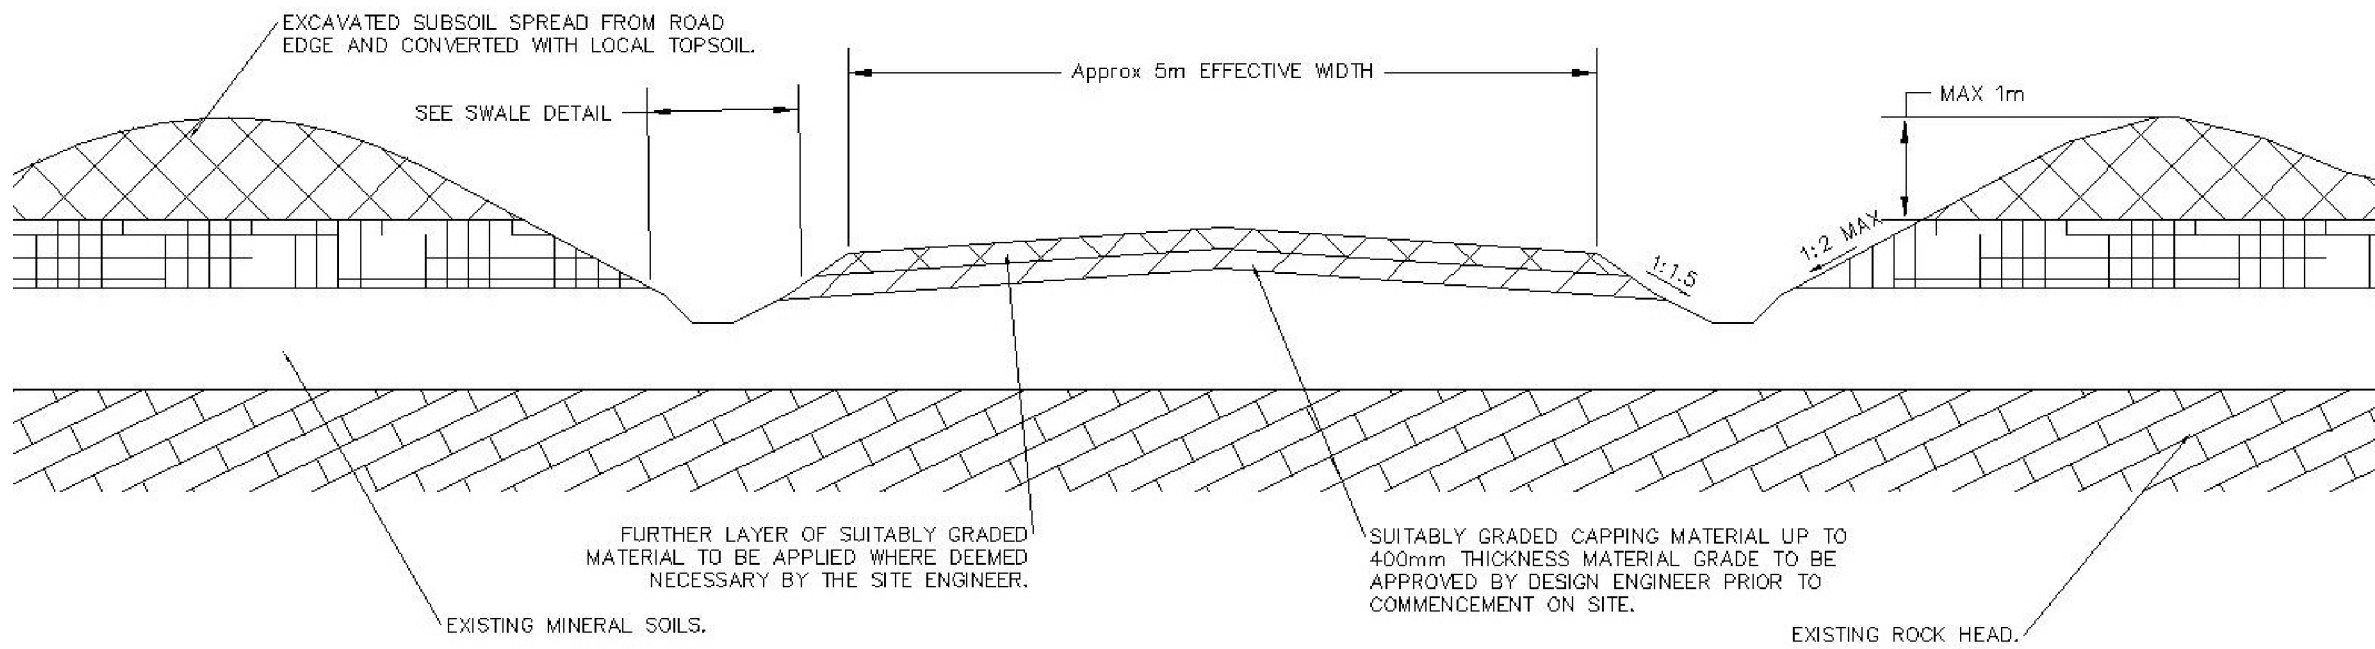
TYPICAL TRACK FORMATION ON OVERBURDEN SOIL
